Microstructural changes in cartilage and bone related to repetitive overloading in an equine athlete model

Sean Turley, Ashvin Thambyah, Neil Broom

Experimental Tissue Mechanics Laboratory, Department of Chemical and Materials Engineering, University of Auckland

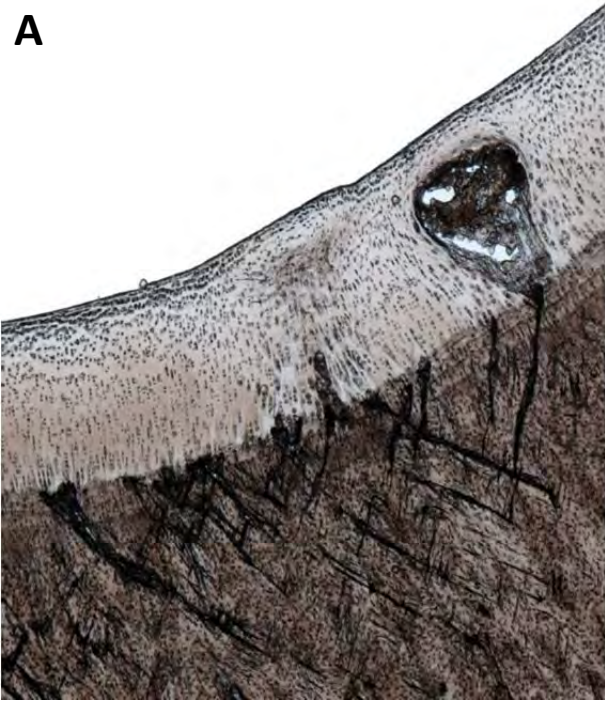
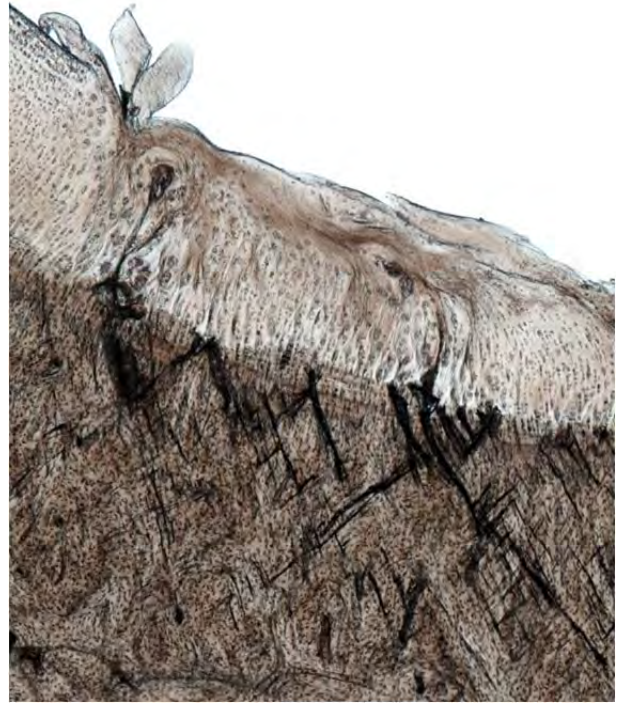
Figure 5: Horse 13 showing lesions in the hyaline cartilage and extensive microdamage in **(A)** the lateral and **(B)** the medial parasagittal groove. Note the high density of microcracks aligned in a cross-hatch configuration, with many large cracks extending across the calcified cartilage layer. **(C)** Enlarged image of the boxed region in (B). A number of changes can be seen in the hyaline cartilage including cell clustering (white arrow), regions of acellularity (black arrow), and regions of altered chondrocyte alignment suggestive of matrix remodelling (see black arrow heads). Cracks of various sizes can be seen in the subchondral bone.

Microdamage was present in the parasagittal groove in animals of all ages. In the younger horses this damage consisted of occasional mid-sized cracks through the calcified cartilage (Figure 5), sometimes terminating in lesions in the deep zone hyaline cartilage (see arrows in Figures 4B & C). This damage was often accompanied by clusters of much smaller cracks in the subjacent bone (see boxed region in Figure 4B). Further, there was some evidence that intense microcracking in the calcified cartilage was linked with a localised area of lesser calcified cartilage thickness, giving the appearance of a recess in the tidemark (see arrows in Figure 5C).

With increasing age a greater intensity of subchondral bone damage was observed and the cracks in the calcified cartilage were generally larger and more numerous, and they more frequently penetrated into the hyaline cartilage (Figure 5). It should be noted that the cracks in both the subchondral bone and the calcified cartilage of the parasagittal groove were aligned at approximately 45° to the local articular surface, and at higher densities had an oblique/counter-oblique intersecting morphology, with cracks of varying sizes forming fractal arrays (see especially enlarged Figure 5C).

As also seen in the younger animals, where the cracks advanced across the most distal tidemark they were often associated with lesions in the hyaline cartilage. In the older animals these lesions were generally more pronounced, with some extending almost to the articular surface (Figures 5A & B). The hyaline cartilage matrix immediately adjacent to these lesions was clearly modified both in terms of cell clustering, acellularity and matrix alignment as indicated by the lines of chondrocyte continuity (Figure 5C). As in the younger animals, focal areas of lesser calcified cartilage thickness could occasionally be found in association with intense microdamage (Figure 5C).

The close association between lesions in the hyaline cartilage and microdamage in both the subchondral bone and calcified cartilage across the entire age spectrum (see Figures 4 and 5) suggests that hard tissue fracture that impinges directly on the deep-zone hyaline cartilage leads to some form of reactive response in the cartilage with subsequent lesion formation. Additionally, these cartilage lesions bear some resemblance, in both morphology and location, to previously described extrusions of mineralised matrix (Boyde, Riggs et al. 2011). Although our imaging technique did not allow us to determine whether or not the contents of the lesions in the hyaline cartilage (e.g. Figure 5A) were mineralised, it is conceivable that they may represent a related form of pathology. Further, where these lesions were associated with voids (see Figure 4B) they may well have resulted from the artefactual loss of mineralised fragments during preparation.

The microdamage in the mid-condylar region, while having many morphological features in common with those observed in the parasagittal groove, differed significantly in the type and severity of lesion developed. The mid-condylar region of younger horses typically lacked any visible sign of damage (Figure 6), with the very dense subchondral bone being the only evidence of high *in vivo* loading (Figure 3). The few lesions that were present in the younger animals appeared to correspond to similar but more advanced lesions in the older animals (c.f. Figures 7 & 8; 9 & 10). In these older animals the mid-condylar lesions were frequently of greater severity and more extensive than those in the parasagittal groove (c.f. Figures 5 & 8),

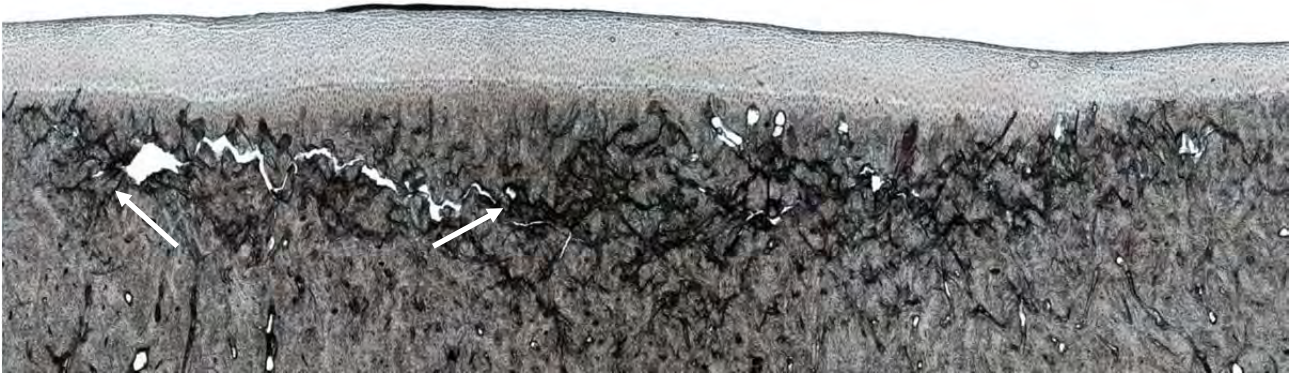
Figure 9: Horse 4 showing accumulation of substantial microdamage in the subchondral bone beneath intact hyaline cartilage. Note coalescence of smaller cracks into a larger lateral fracture whose span is indicated by the white arrows.

The second of the two mid-condylar lesions noted in the 3 younger animals exhibited obvious subchondral damage spread across a large area (Figure 9), and corresponded to macroscopically observed bruising (as in Figure 2B). The subchondral bone microcracks in this region are chaotic, exhibiting less clearly the oblique/counter-oblique morphology noted earlier. Further, microcrack coalescence has resulted in the formation of a larger laterally-spreading fracture in the subchondral plate (see region arrows in Figure 9).

While severe subchondral bone damage in the mid-condylar region often occurred with no visible damage to the overlying articular surface (see Figures 9 and 10), eventually the hard tissue damage appears to escalate such that the deep hyaline cartilage is compromised. For example, the RH extremity of the main coalesced crack in Figure 10A has penetrated the calcified cartilage and hyaline cartilage to create what appears to be an incipient cartilage lesion (enlarged in Figure 10B). More severe examples are shown in Figure 8A where subchondral bone collapse has caused the hyaline cartilage to fold inwards into a void in the subchondral plate. The fibrous “neo-tissue” at the articular surface at these sites of cartilage infolding (see Figure 7; arrowed sites in Figure 8A; Figure 8C) appears to be reparative in nature, and would help to maintain congruency in the joint following the collapse of the subjacent subchondral bone. Our microstructural evidence indicates that this reparative tissue differs structurally, and perhaps even materially, from the original hyaline cartilage (see Figures 7B and 8C), but its exact nature remains unclear.

It is important to note that much of the subchondral damage observed in this study was only subtly apparent from external examination of the joint surface. Outwardly intact hyaline cartilage often masked significant hard tissue microdamage in both the parasagittal groove and the mid-condylar region (e.g. Figures 5A & 9), and even in cases of significant disruption to the cartilage (i.e. subchondral collapse, see Figures 7 & 8), the formation of fibrous neo-tissue concealed the full extent of the injury. Additionally, mild bruising of the subchondral bone, barely visible through the intact cartilage, corresponded to moderately high levels of hard tissue microdamage (Figures 9 & 10).

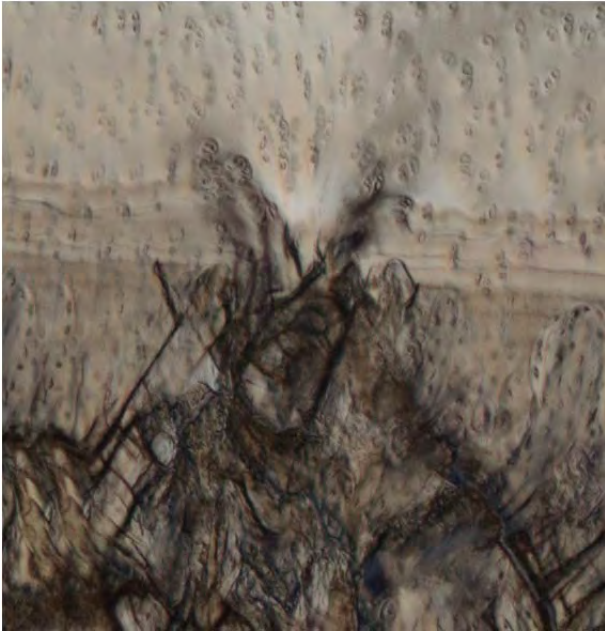
Figure 11: Horse 14 showing a calcified cartilage recess in mid-condylar region of associated with microcracking.

Finally, a clear example of a tidemark recess was found in the mid-condylar region (Figure 11), similar to that seen in the parasagittal groove.

All of the 10 younger horses had microdamage in the parasagittal groove, whereas only 3 had detectable damage in the mid-condylar region (see Table 1). This contrasts with the 6 older horses where both parasagittal and mid-condylar damage were detected in all but one case. This suggests that microdamage development in the parasagittal groove precedes that in the mid-condylar region. Additionally, in the younger animals damage in the calcified cartilage of the parasagittal groove was noticeably more severe than that in the underlying subchondral bone (Figure 4), suggesting a predisposition to failure in the calcified cartilage at this site. Indeed, for all ages of animal, microcracking of the calcified cartilage was typically of greater intensity in the parasagittal groove than in the mid-condylar region, where cracks in the calcified cartilage were relatively infrequent even in the presence of severe subchondral bone damage (see Figures 8B, 9, 10C). This apparent predisposition to microdamage of the calcified cartilage in the parasagittal groove is most likely due to differences in loading conditions between the two sites. Further, evidence that this hard tissue microdamage might interfere with the normal calcification process is provided by the pronounced recesses observed in the most distal tidemark of the ZCC in the regions of intense microcracking (see Figures 4C, 5C, 11).
